GAZA SOLID WASTE MANAGEMENT PROJECT (ADDITIONAL FINANCE RBF)

JSC Semi Annual Report: Environmental and Social Compliance

(January 2022 - June 2022)

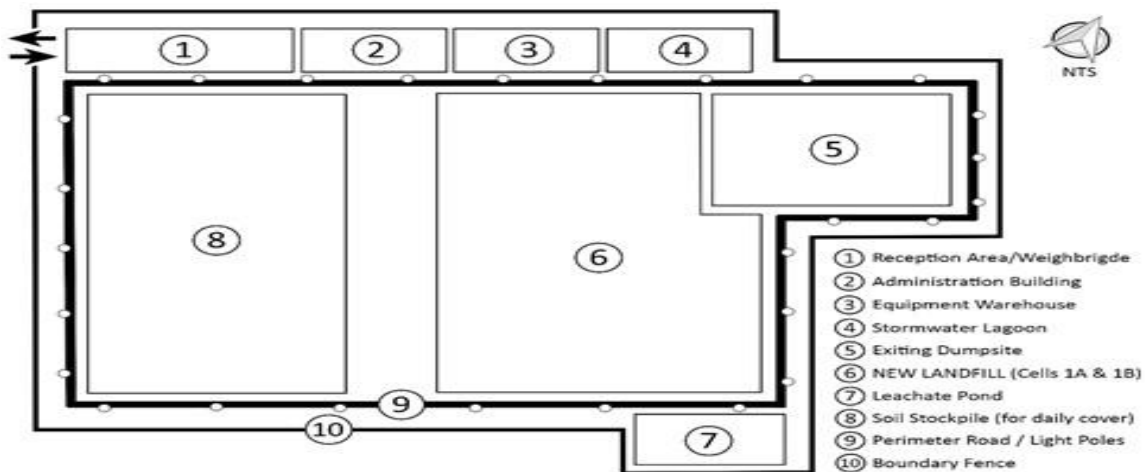
Figure 1. Schematic of Sofa Sanitary Landfill in Al-Fukhari

Al-Fukhary (Sofa) Sanitary landfill consist of:

- Entrance area including weighbridge and control room;
- Building (190 m² on 3 levels) for JSC-KRM operation personnel staff;
- Maintenance Workshop (528 m²); Storm water drainage and storage pond (10,531 m³ capacity);
- Disposal cell 1, divided in cell 1A and 1B (excavated up to 20 m below natural ground level), and slope 1:2 for sides with horizontal perm 5m width;
- Leachate pre-treatment (aeration lagoon, usable volume 10400 m³), it is excavated to 2.75 m below natural ground level;
- Peripheral road (length 1,735 m);
- Old Dumpsite (40,000 m²);
- Stockpile of excavated soil (85,000 m²); and
- Fence is surrounding all the site.

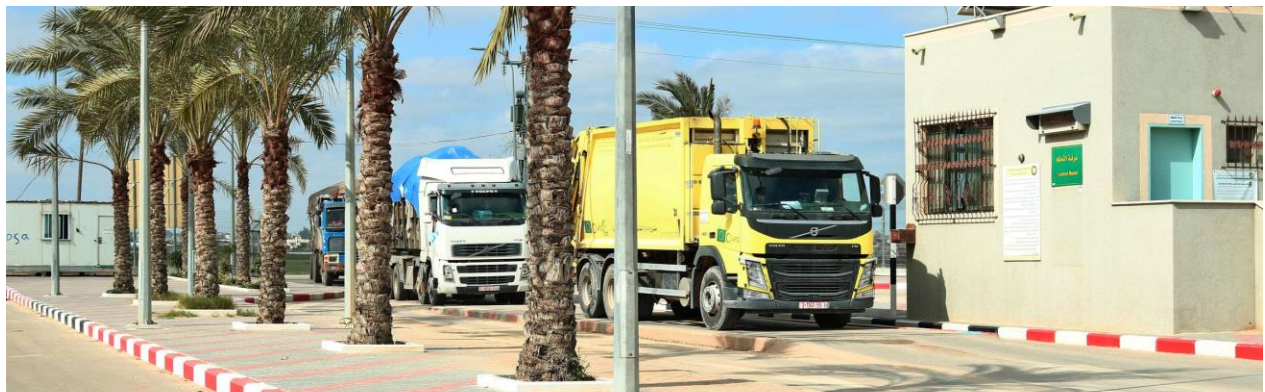
Figure 2. Reception of Waste at Al-Fukhary Landfill

The control room and the weighbridge are located near the entrance and are to be managed at all times. The following data are obtained from all vehicles entering the site which carry waste time and date, vehicle registration details, weight and type of waste.

The control room employee asks about the type of wastes entering the site initially, and the observer (flagman), who manage the filling of waste at the disposal cell, observes the type of waste as a second level of observation. The landfill was designed to receive only municipal solid waste, as well JSC-KRM regulations state a list of waste which is not acceptable to be received at the landfill. The list of prohibited wastes is printed and installed in front of the landfill gate. Table (3) shows the list of prohibited waste

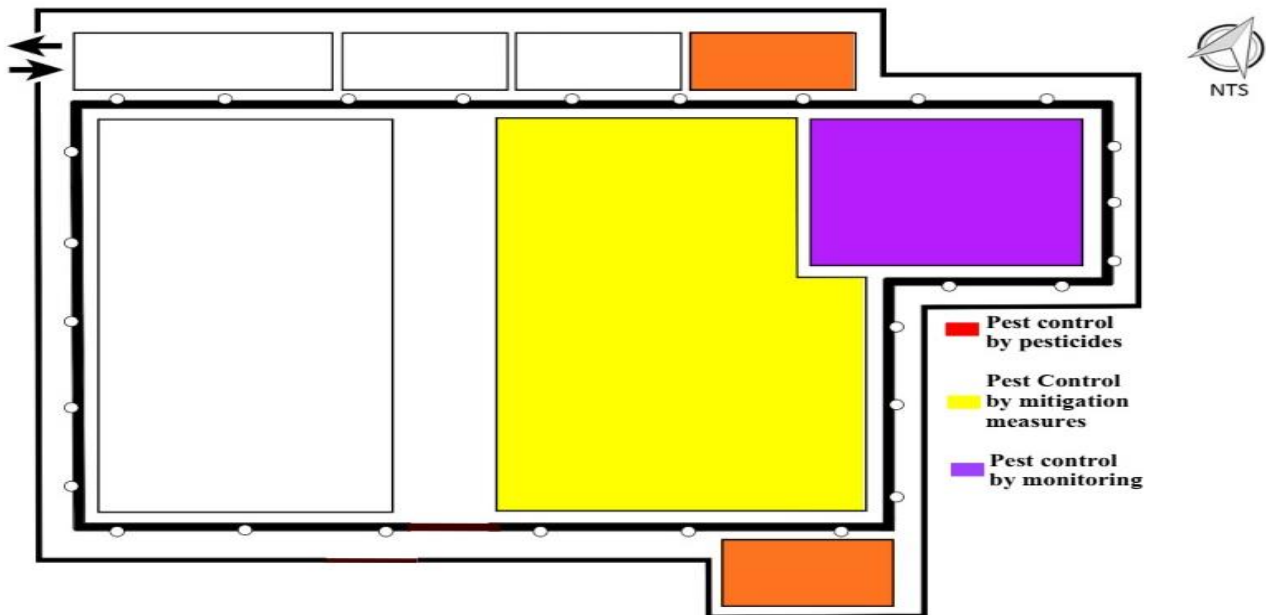
Figure 3. Levels of pest management at Al-Fukhary (Sofa) Sanitary landfill

A pest management plan has been prepared for Al-Fukhary Landfill during operation. The plan categories the source of pesticides and level of required measure as shown in Figure (2).

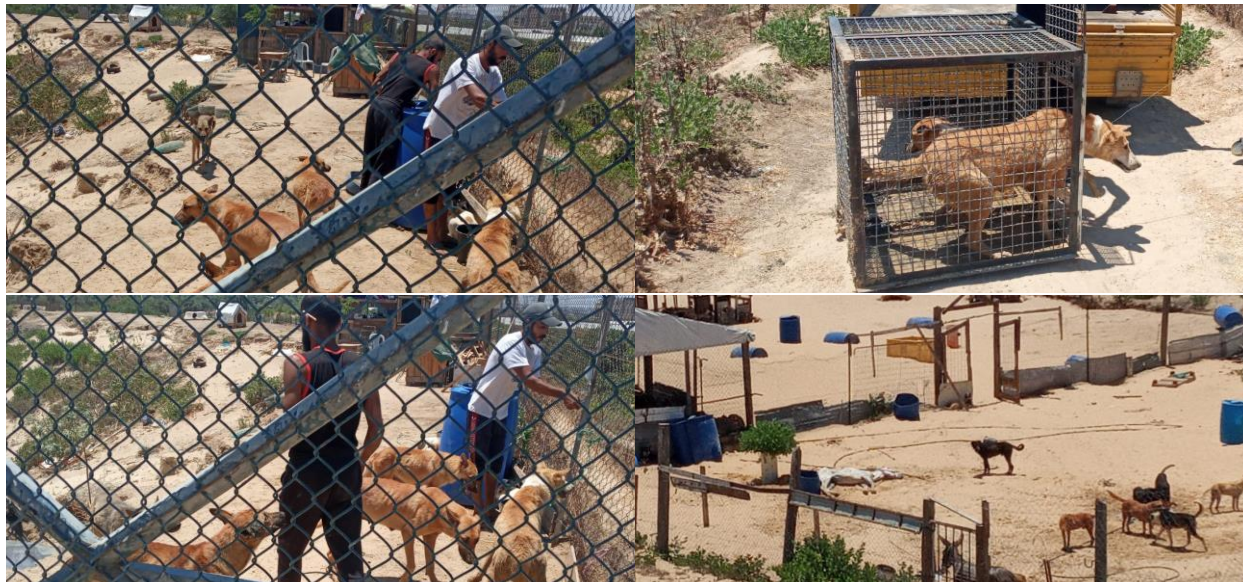
Figure 4. Transferring the animals to SULALA

On June, 2022, JSC-KRM landfill workers and guards collected 10 dogs and transferred them to the Shelter in Gaza City under the project's environmental officer supervision.

The Landfill guards were requested to prevent any of stray dogs to access to the landfill from the gate, knowing that the gate is the only possible place for accessibility of dogs, and also to report any new animals entering the site to repeat the exercise with respect to coordinating with the animal shelter.

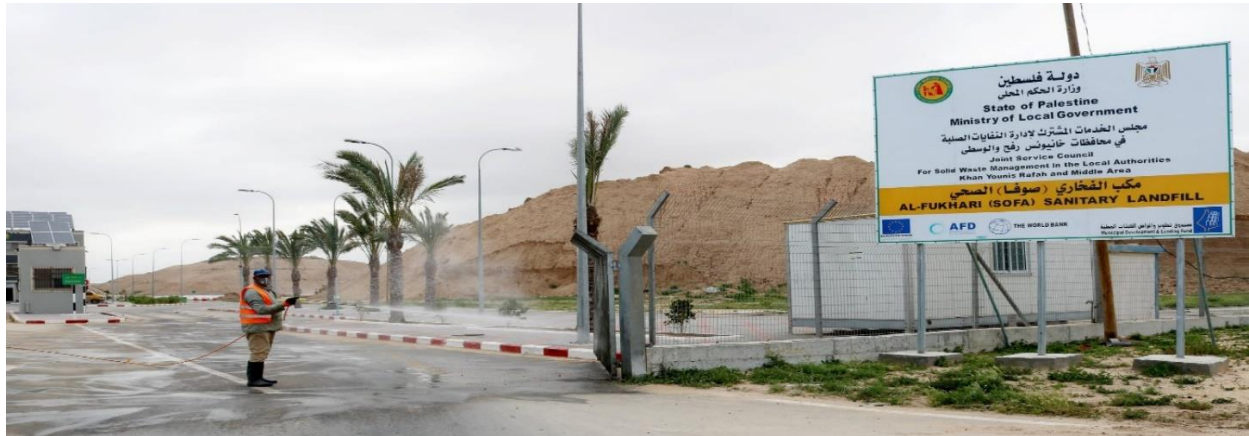
Figure5 . Sterilization of internal roads and facilities landfill

The health and safety of workers is the top priority at Al-Fukhary site. Workers were provided by training related to precaution measures regarding to COVID-19, as well they were provided by daily safety instructions. Workers at al-Fukhary landfill was provided with a full PPE (Vest, Safety Shoes, Masks, hats, gloves). In addition, the sterilization of internal roads and facilities landfill twice a week using chlorine.

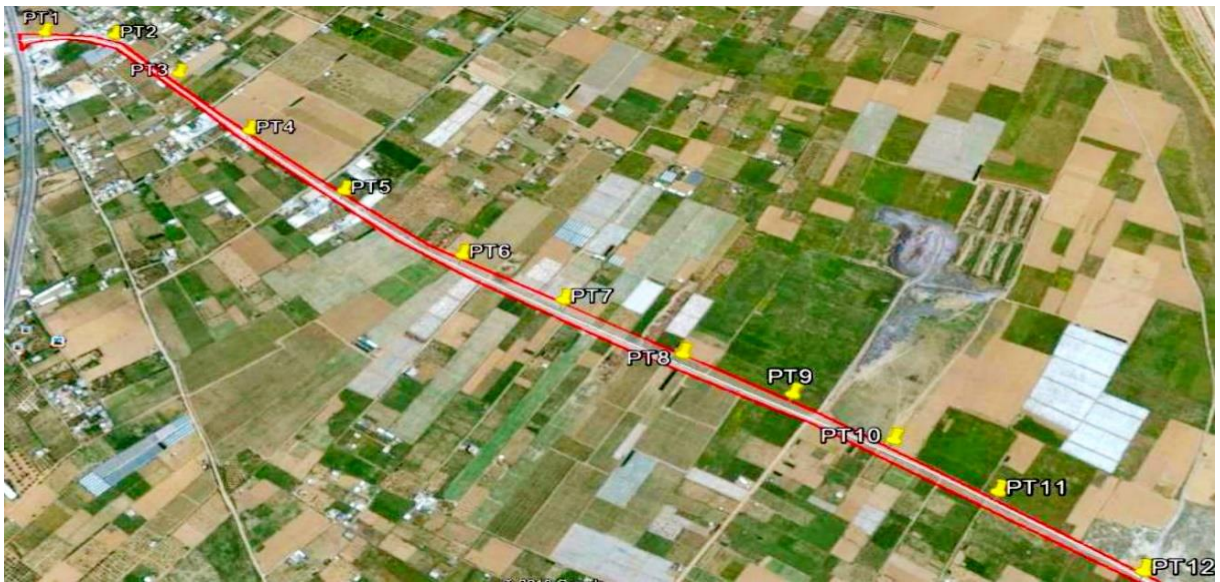
Figure 7. Access Road layout

Sofa road is used as access road to Sofa Solid Landfill, it has an access from Salah Al Dein Street and ends at the armistice borderline. Access road status is considered as not good due to the deep damage in large parts of its body. Figure (9) shows the location of the road. The length of the road is approximately 2.5 Km (from Salah Al Dein Street to the access gate of the landfill), knowing that the remaining length (from the access of the landfill to the borderline) will not be taken into account within this project. The width of existing access road varies from 4m to 6m in some parts.

Improvements of the Sofa landfill access road were implemented. Such improvements consist of road widening in some narrow parts without removal of any trees, structures or infrastructures, and paving/rehabilitate of some damaged parts and expanding the pavement width up to 7.5 m, and final pavement cover were paved for all the road. Moreover, the rehabilitation included the cleaning of the access road from any dumped waste along the road.
