# **GAZA SOLID WASTE**

# MANAGEMENT PROJECT

# JSC Quarter Annual Report:

**Environmental and Social Compliance**

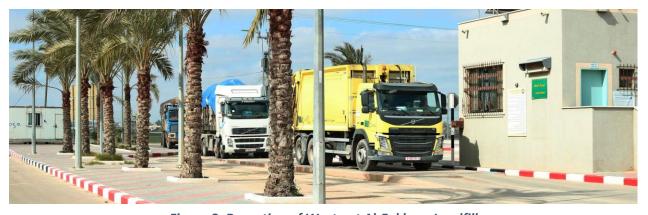
The control room and the weighbridge are located near the entrance and are to be managed at all times. The following data are obtained from all vehicles entering the site which carry waste time and date, vehicle registration details, weight and type of waste.

The control room employee asks about the type of wastes entering the site initially, and the observer (flagman), who manage the filling of waste at the disposal cell, observes the type of waste as a second level of observation. The landfill was designed to receive only municipal solid waste, as well JSC-KRM regulations state a list of waste which is not acceptable to be received at the landfill. The list of prohibited wastes is printed and installed in front of the landfill gate. Table (3) shows the list of prohibited waste

Figure 2. Reception of Waste at Al-Fukhary Landfill

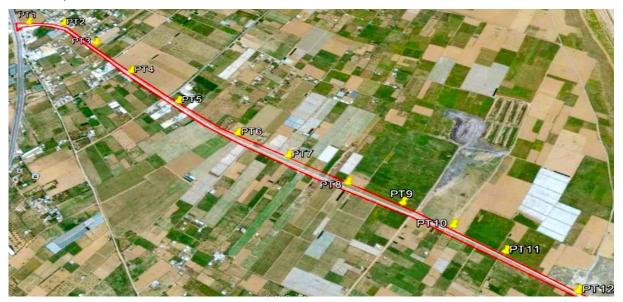
Sofa road is used as access road to Sofa Solid Landfill, it has an access from Salah Al Dein Street and ends at the armistice borderline. Access road status is considered as not good due to the deep damage in large parts of its body. Figure (9) shows the location of the road. The length of the road is approximately 2.5 Km (from Salah Al Dein Street to the access gate of the landfill), knowing that the remaining length (from the access of the landfill to the borderline) will not be taken into account within this project. The width of existing access road varies from 4m to 6m in some parts.

Figure 37. Access Road layout

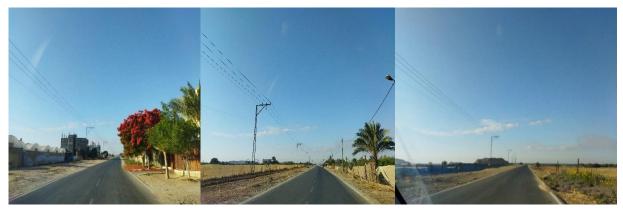
Photo: Sofa Landfill Access Road

Improvements of the Sofa landfill access road were implemented. Such improvements consist of road widening in some narrow parts without removal of any trees, structures or infrastructures, and paving/rehabilitate of some damaged parts and expanding the pavement width up to 7.5 m, and final pavement cover were paved for all the road. Moreover, the rehabilitation included the cleaning of the access road from any dumped waste along the road.
